# Making Schools Safer for Earthquakes

**Effectiveness of Retrofitting:**  
*Case Studies from Nepal*

**November 2016**

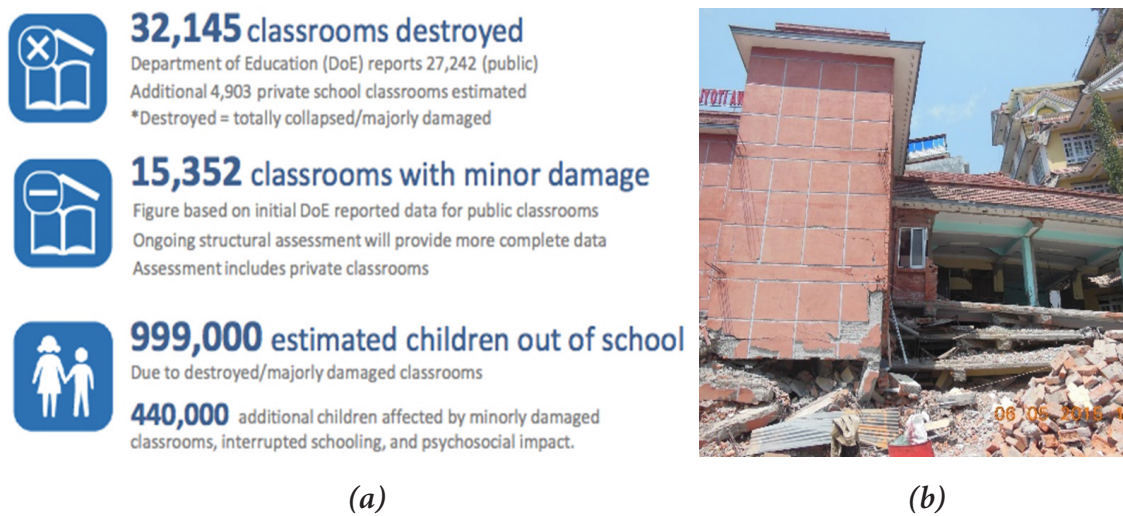
**Figure 1:** (a) Survey data from Education cluster (the coordinating body for humanitarian education activities) showing the approximate estimate of damage in the earthquake (b) Completely damaged Deepjyoti School in Gongabu, Kathmandu lacking proper seismic details.

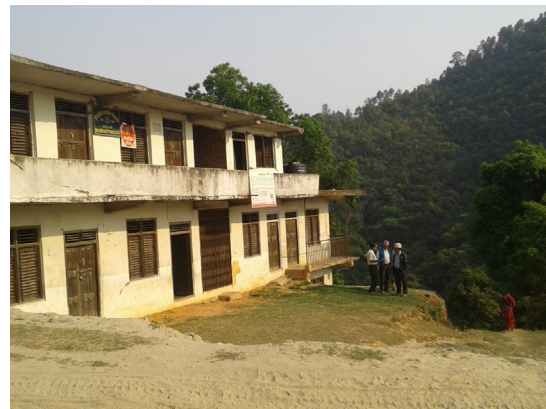
**Figure2:** Typical load bearing masonry school building which experienced moderate shaking in Kavrepalanchowk, it became unsafe due to major cracks in unreinforced partition walls.

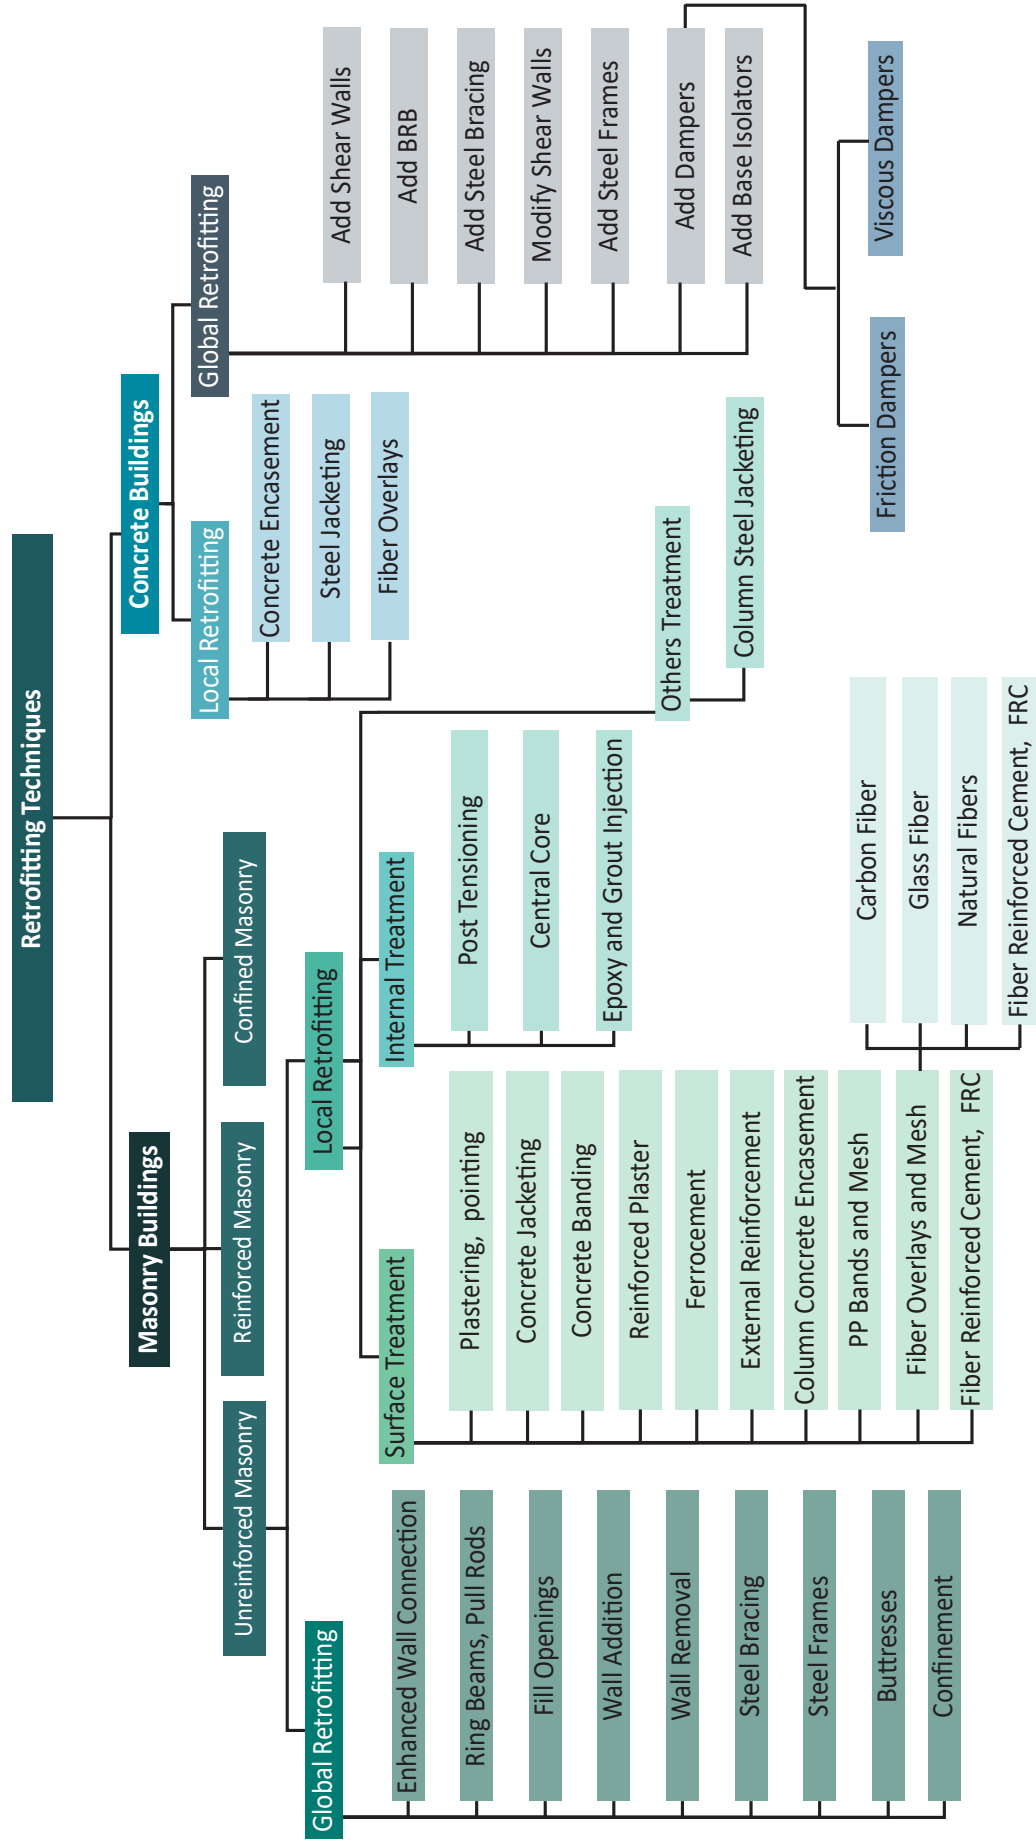
Figure 4: A chart showing retrofitting techniques used around the world for masonry as well as RCC buildings for local and global retrofitting.

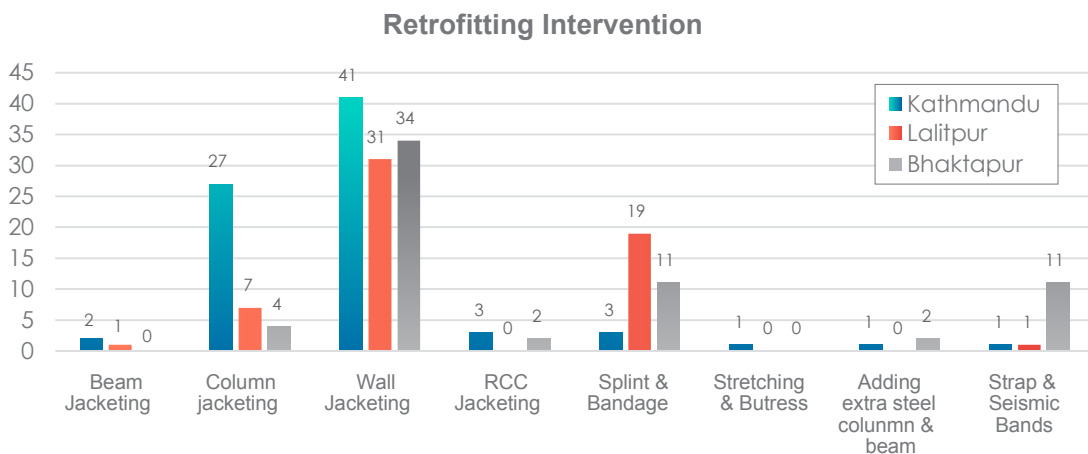
**Figure 5:** Retrofitting intervention by World Bank survey (SIDA) shows retrofitting techniques in Kathmandu valley.

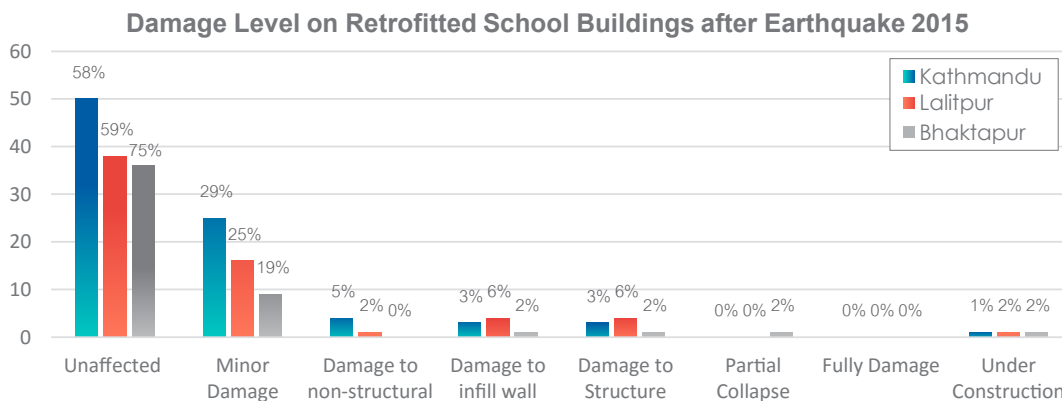
Recent survey on school buildings inside Kathmandu valley by World Bank (SIDA 2016) after Gorkha earthquake shows majority of the retrofitted school buildings perform well in the earthquake as compare to non-retrofitted school buildings.

**Figure 6:** Damage state of retrofitted blocks of school buildings in Kathmandu valley (Source: SIDA 2016)

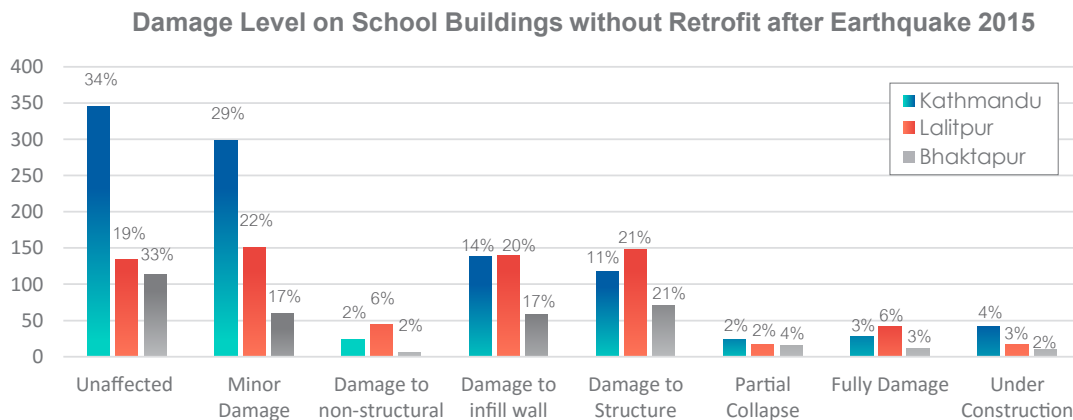
**Figure 7:** Damage state of non- retrofitted blocks of school buildings in Kathmandu valley (Source: SIDA 2016)

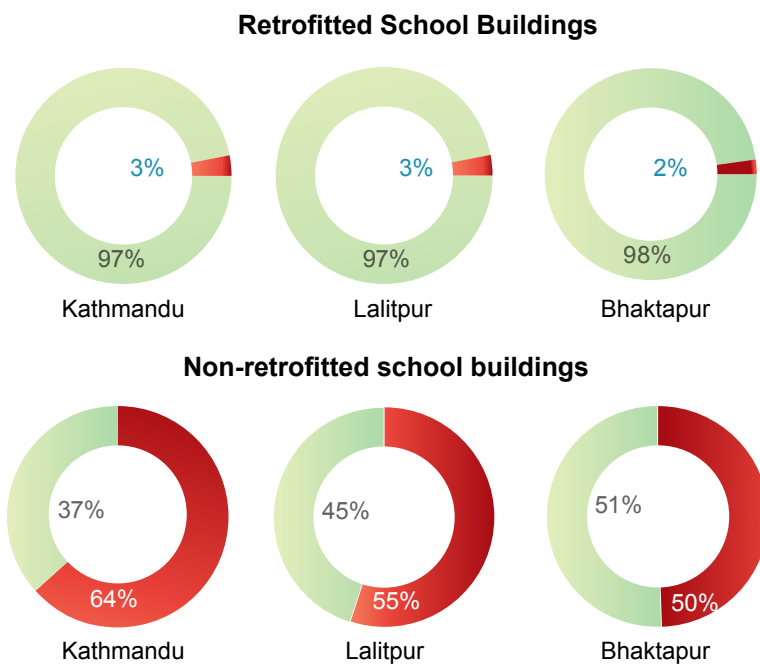
**Figure 8:** Tag color in retrofitted and non-retrofitted school buildings. Green color represents that immediate occupancy can be undertaken and Red represents that building is vulnerable for immediate use.

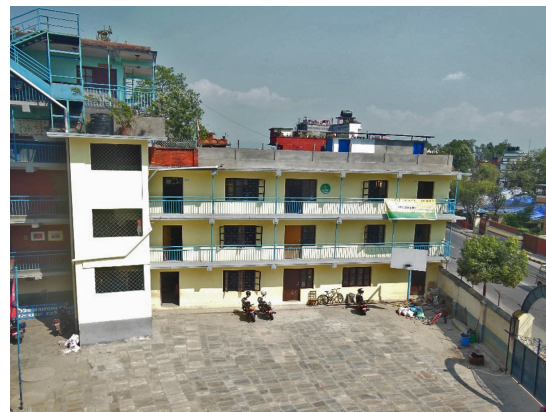
Retrofitted school buildings performed satisfactorily well with minor hairline cracking to almost no damage. In some locations of Kathmandu valley, concentrated effects of the earthquake were seen, where retrofitted school buildings were able to withstand the earthquake effects compared to surrounding non-retrofitted school buildings and other residential buildings. Three retrofitted school buildings show minor damage (cracks in infill wall) but the overall performance of the school buildings was enhanced by concrete jacket and splint-bandage.

**Figure 11:** A school building in Kathmandu shows different response. The building originally was load bearing masonry retrofitted with concrete jacket and was undamaged and was available to continue classes after earthquake.

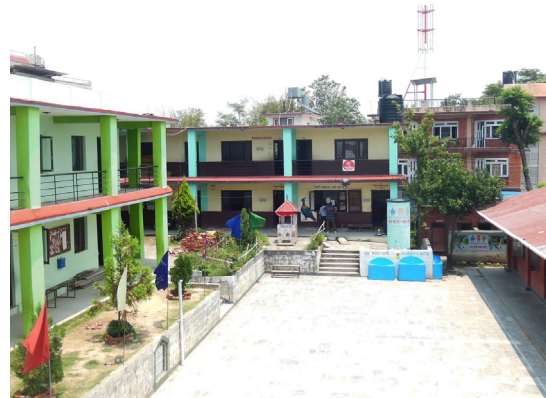
Non-retrofitted school buildings performed poorly compared to retrofitted school buildings. Most of the school buildings experienced minor to severe damage in the earthquake. The damage in non-retrofitted schools was not only limited to concentrated areas of Kathmandu valley but also in majority of the surveyed locations. Some of the school buildings were completely collapsed after the shaking. The damage in non-retrofitted schools are extended to URM buildings to RCC framed buildings. In the concentrated areas where stronger ground shaking was seen, the school buildings performed poorly. The major problem was low strength brittle constructions lacking minimum seismic detailing which makes it more vulnerable to strong ground shaking.

**Figure12:** A school building in Kathmandu shows different response. The building at the back, load bearing masonry was moderately damaged in the earthquake and the building at the left, load bearing masonry, retrofitted with concrete jacket was undamaged and was available immediately for restarting classes after earthquake.

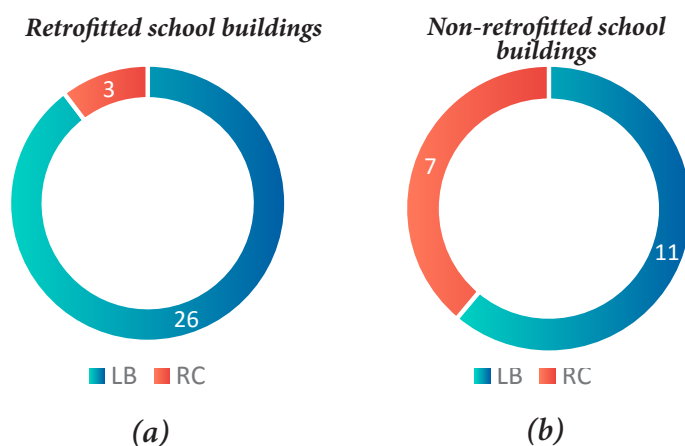
Depending upon the structural system used in the buildings, the school buildings are divided according to structural typologies into two main systems: Load bearing masonry (LB) and reinforced concrete framed (RC) systems. 26 blocks are retrofitted load bearing and 11 blocks are non-retrofitted load bearing blocks and 3 blocks are retrofitted framed buildings and 7 blocks are non-retrofitted framed blocks.

**Figure21:** Summary for retrofitted and non-retrofitted school buildings in three districts inside Kathmandu valley divided by structural typology
